Evaluating a Prefabricated Submerged Breakwater and Double-T Sill for Beach Erosion Prevention, Cape May Point, NJ

Donald K. Stauble¹ and Michael A. Giovannozzi²

ABSTRACT

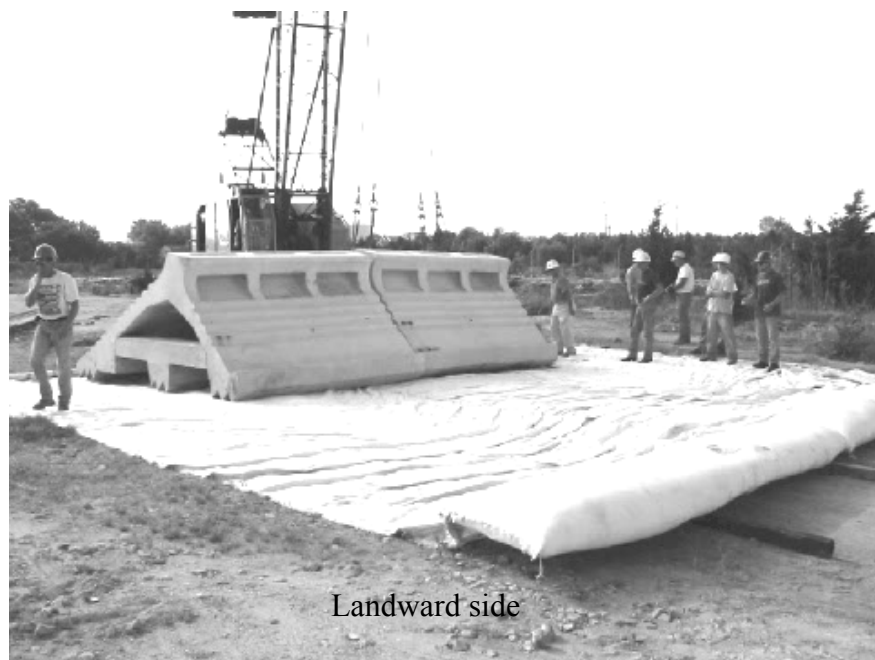
Figure 4. Geotextile fabric mat base for Beachsaver Reef™

The approximate 18 sq m geotextile mat had a pillow structure filled with concrete on the landward edge to anchor the mat to the bed. The rolled up geotextile mat was deployed by a barge-mounted crane. Once on the bottom, the mat was extended seaward. Three interlocking Beachsaver Reef™ units were then placed on the seaward side of each geotextile mat with the use of the crane. Divers were used to align the individual units and insure that the interlocking was accomplished.

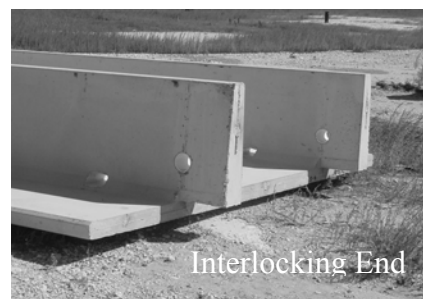
Figure 5. Double-T sill dimensions and placement configuration

In cell 6, a prefabricated concrete Double-T structure was placed and is expected to act as a sill across the seaward end of that cell to create a perched beach. The name comes from the shape of the precast concrete units with two vertical legs on a flat base when viewed on its end looks like two TT's. This Double-T design is typically used for parking garage supports. The units for this particular application for coastal erosion prevention are made of marine grade concrete and reinforced with coated rebar. The 9.14 m-long and 3.66 m-wide units are placed end to end in an inverted position with the flat surface on the sand bed at -2.7 m depth (Figure 5). The vertical legs extend 0.8 m in the water column and a single unit has a weight of 17.3 metric tons. For this application, an extension of the legs on one end of each unit allowed an interlocking effect between the units, designed to maintaining a linear orientation of the sill. The sill was located near the seaward end of the groins and was attached to the groins at both ends by rock, creating a closed structure.

down when placed on the barge. A crane was attached to the inverted legs and the unit was lifted off the barge and placed on the bottom. Divers assisted in the alignment and interlocking as the units were placed on the seabed. Surveys of cell 6 in March and June 2002 indicated that the -2.7 m NAVD contour straight and parallel to the shoreline near the seaward end of the groins and did not change over time. No excavation or fill was needed to place these units and no filter cloth was used as a base. With a length about three times that of the Beachsaver Reef™ units, only 22 units were needed to span the 200 m of the cell. It only took four working days to complete this installation between 26 September and 2 October 2002.
